Manhole Inspection Summary

Manhole # S21E__005MH

Insp Date: **10/15/07 1:18 PM**

Location Address: **320 KIRBY-FULTON** Cross Street: **MULBERRY ST**

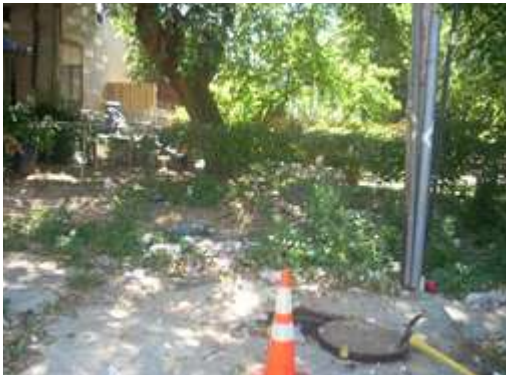
Location View

DEBRIS ON BENCH AND IN CHIMNEY

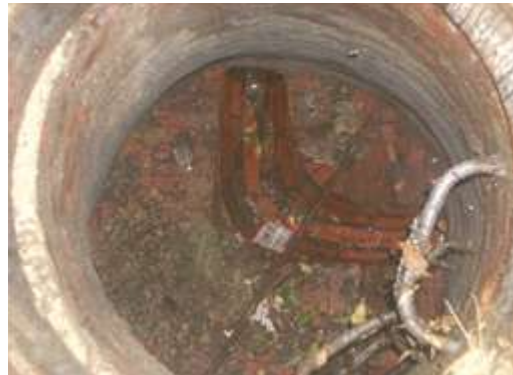
Top View

DEBRIS ON BENCH AND IN CHIMNEY

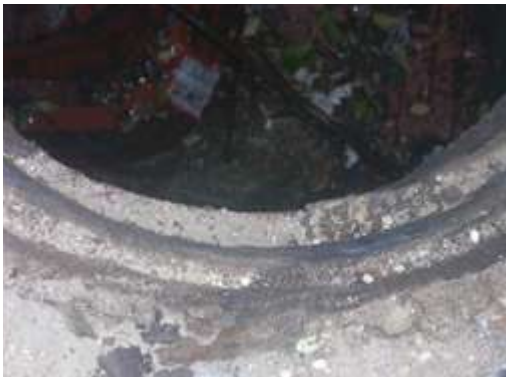
Defect 1

Frame Offset: **1** (in.) Condition: ☒ Sound ☐ Cracked ☐ Leaks

FRAME OFFSET

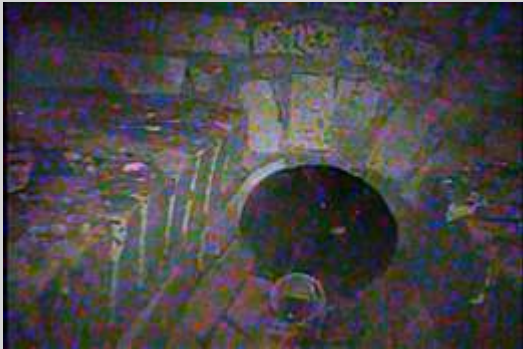
12 O'Clock Outflow

8 in. Circular Gravity Sewer
Pipe Out @ 12 O'Clock

Pipe Height: **8.4** (in.) Rod and Bar (Angled)
Pipe Material: **Clay** ☐ Pipe Lined
Invert Depth: **8.86** (ft.) Flow Characteristics: **Slow**
Deposits: ☒ None ☐ Mud ☐ Sludge ☐ Debris ☐ Grease
Silt Depth: (in.) Deposits Extent:
Infiltration: **None** Pipe Seal Cond: **Sound**

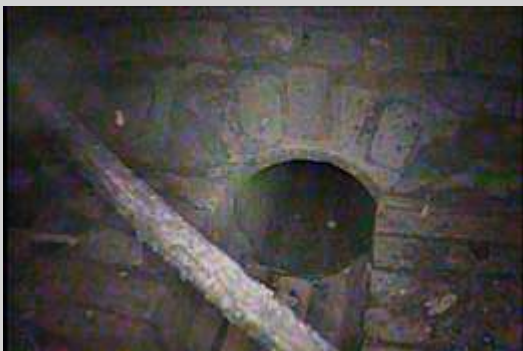
3 O'Clock Inflow

8 in. Circular Gravity Sewer
Pipe In @ 3 O'Clock

Pipe Height: **8.4** (in.) Rod and Bar (Angled)
Pipe Material: **Clay** ☐ Pipe Lined
Invert Depth: **8.17** (ft.) Flow Characteristics: **Slow**
Deposits: ☒ None ☐ Mud ☐ Sludge ☐ Debris ☐ Grease
Silt Depth: (in.) Deposits Extent:
Infiltration: **None** Pipe Seal Cond: **Sound**
